WATER QUALITY IN THE BBB

BOWEN BROKEN
BOGIE CATCHMENT

Improving water quality through landscape
interventions and land management

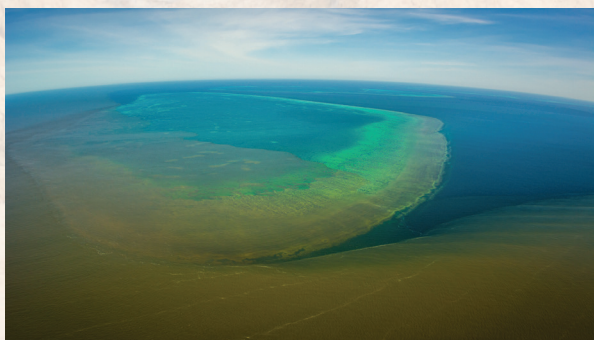
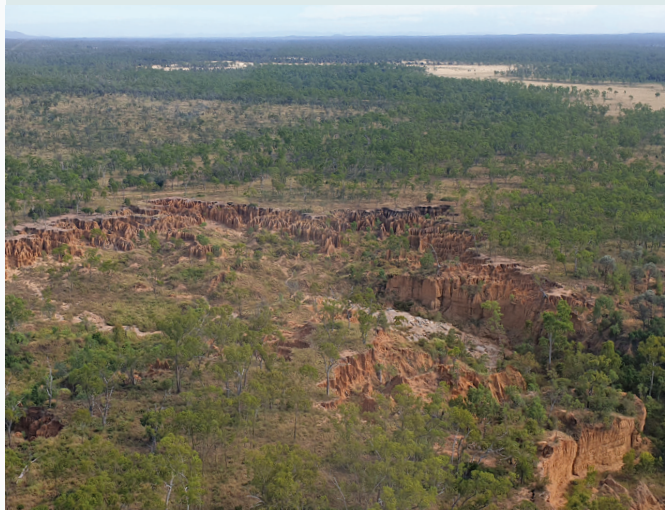
ABOVE: Active gully system in the BBB. INSET: A Burdekin River flood plume. MAIN PHOTO: An untreated gully on Havilah Station near Collinsville.

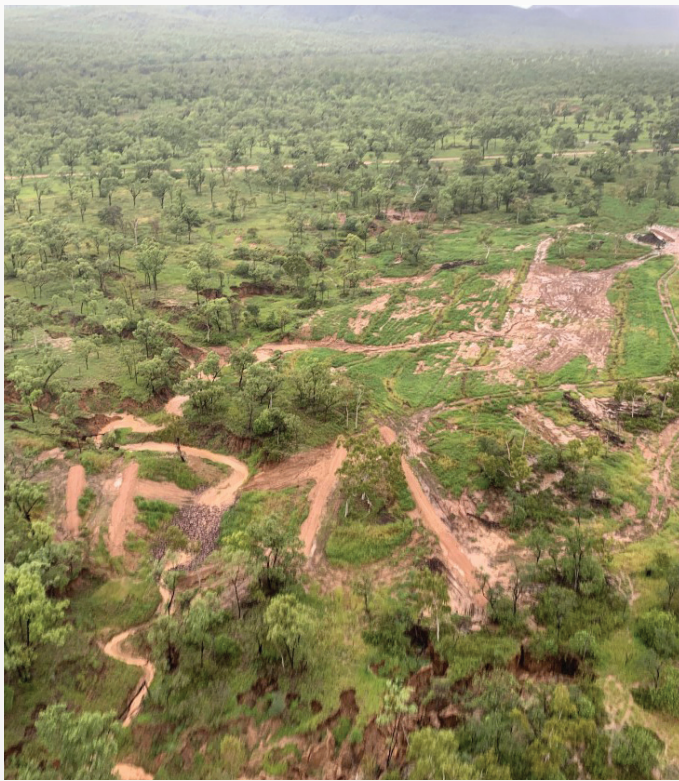
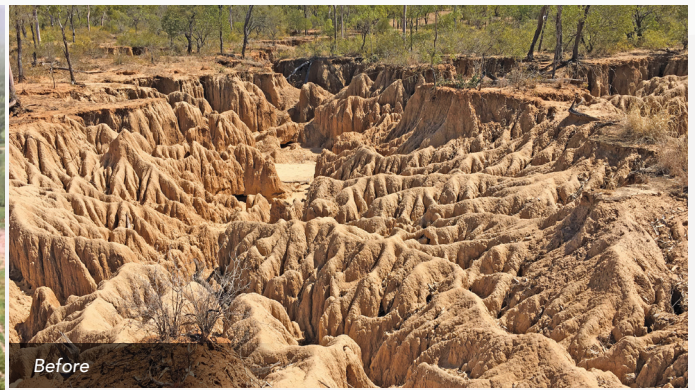
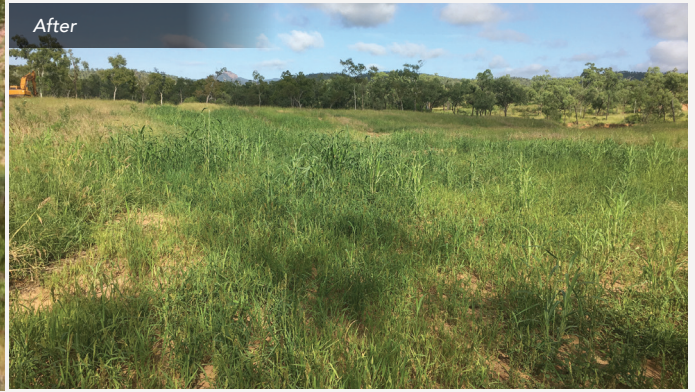
GLEN BOWEN

These photos show the progress of remediation works on the first site. Treatment included reshaping and battering the active gullies, installing rock chutes and bunds to control water movement, and establishing vegetation.

Three sites, covering an area of 10.2ha have been treated. They are part of an extensive gully system adjacent to the Bowen River.

The first automatic monitoring triggered by a rain event early in 2022 showed 52,800mg/L coming from the untreated site compared to 794mg/L at the treated site.

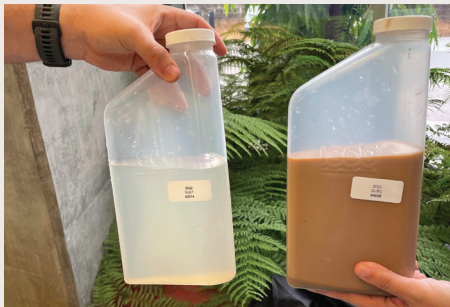
The water samples, (pictured), showed a median sediment concentration from the control site almost 70 times more than the sediment load from the treatment site.

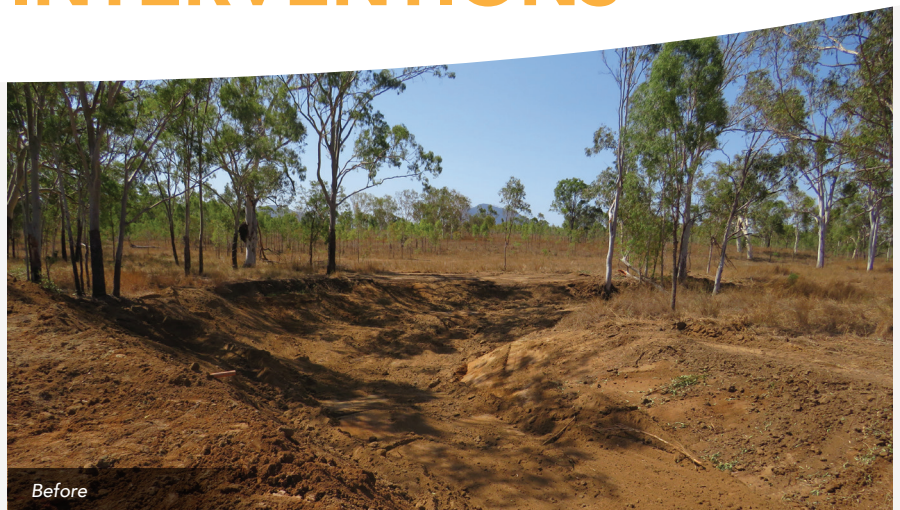
Before

Small-scale, low-cost gully remediation measures installed at the Mt Pleasant Learning Hub on Mt Pleasant Station, near Bowen, are doing what they were designed to do after heavy rain.... holding water in the landscape.

These interventions, also known as landscape rehydration, are designed to restore landscape function by increasing rainfall infiltration and improving water tables. This intervention is complemented by landscape management practices, including sustainable grazing practices aimed at improving soil health and pasture cover.

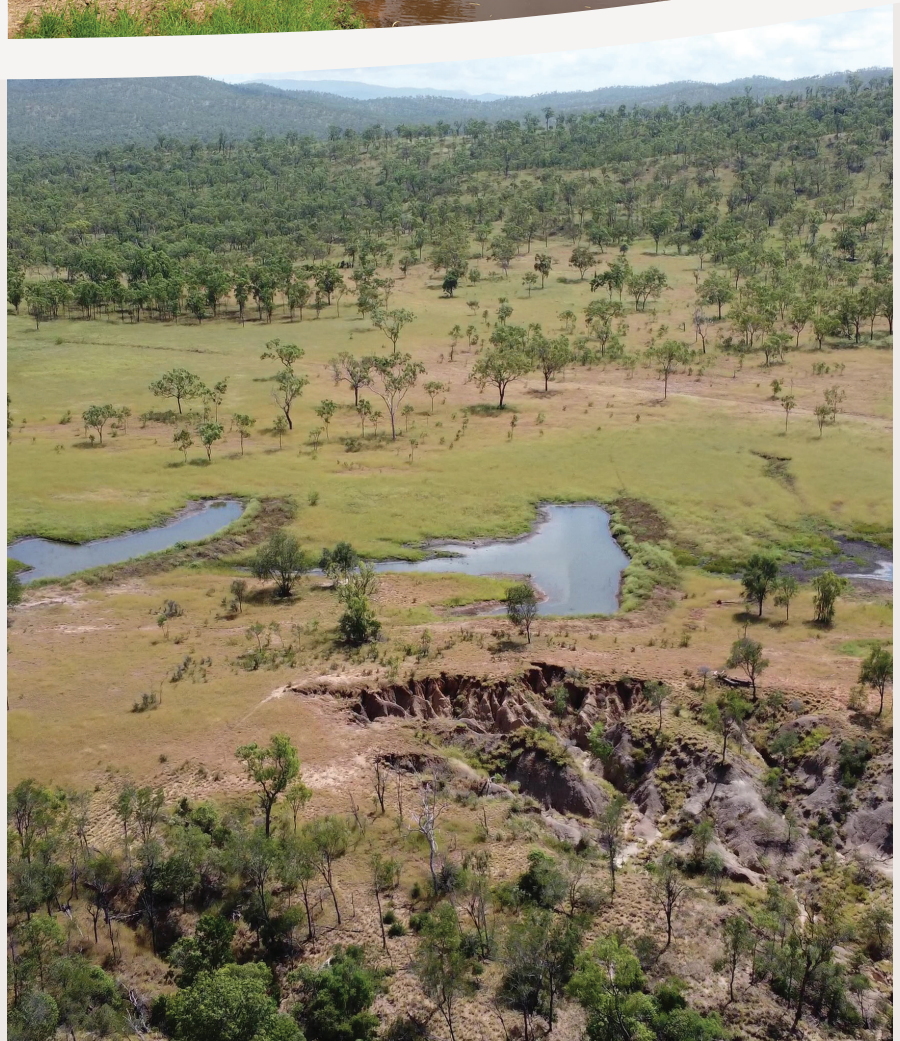
DARTMOOR

Problem: A gully head was encroaching onto productive grazing land.

Solution: A series of rehydration banks, (pictured right), each about 200 metres long, were constructed above the head of a gully. The aim was to halt the progress of the gully head.

Water is now being held in the landscape by the banks instead of running into the gully system, improving water infiltration. The area was seeded with native grasses.

Early indications are positive. A complementary grazing management plan has been implemented to improve ground cover and soil health.

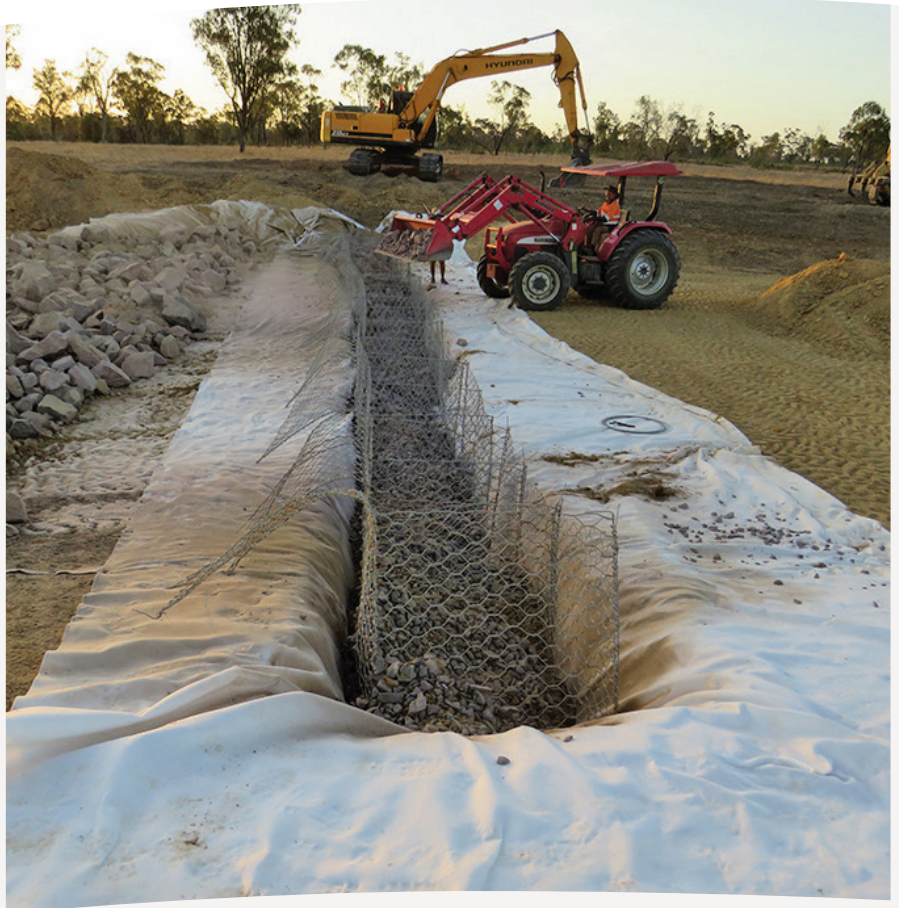
EMOHROU

Problem: The by-wash of a dam, one of the property's major water sources, was too narrow to handle the volume of runoff generated in the catchment.

Solution: The by-wash was widened and reshaped and rock chutes and gabion baskets, (pictured), were installed to prevent existing gullies progressing up the by-wash. A grade bank was built and contour ripping completed upslope to manage surface water flow.

Stock will be reintroduced at this site when a suitable level of ground cover returns.

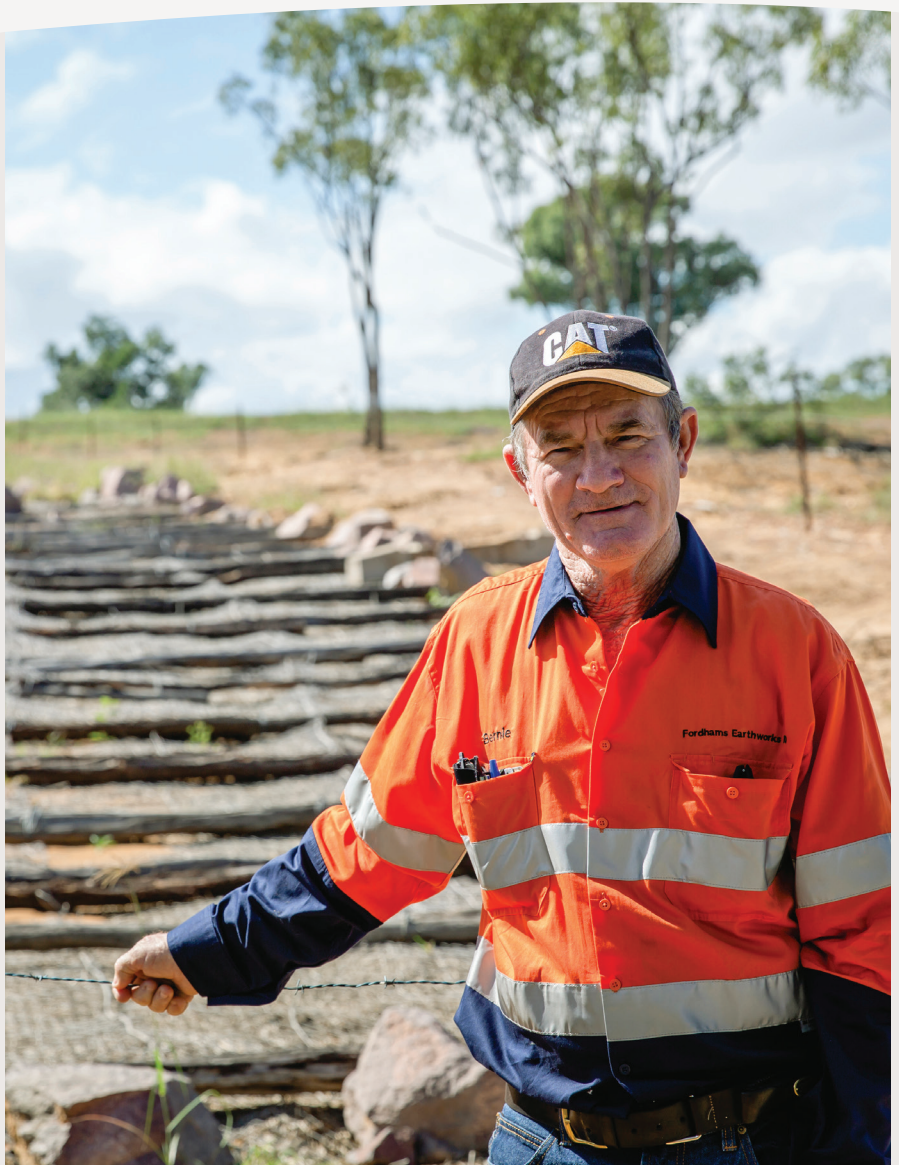
HILLVIEW

Problem: Over-grazing around waterways had resulted in low ground cover generating excess runoff and causing soil erosion.

Solution: Two diversion banks were constructed from each side of a gullied area to divert surface water runoff to a centre point above the gullies. A rock chute, (pictured), was installed to carry the discharge from the diversion banks into the creekline area below.

Works have promoted water infiltration and aided pasture growth.

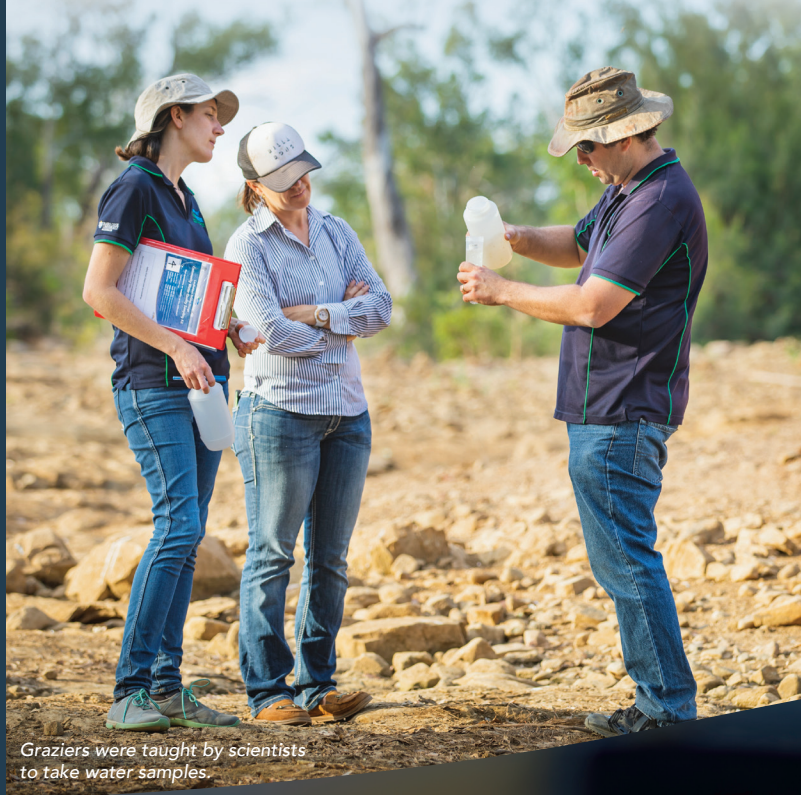
Graziers were taught by scientists to take water samples.
